STAR4D[®] Research on Sherwin Williams CARC Comparison of MIL-D-53039 Silica vs. Mil-D-53039 Polymeric Bead

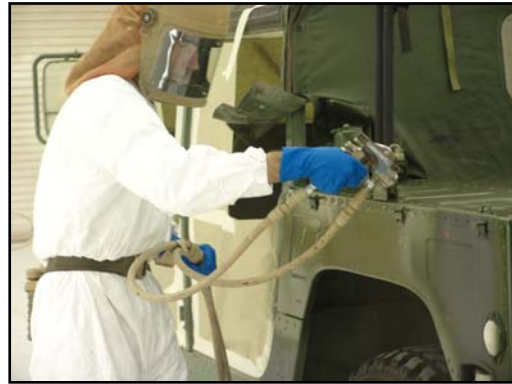
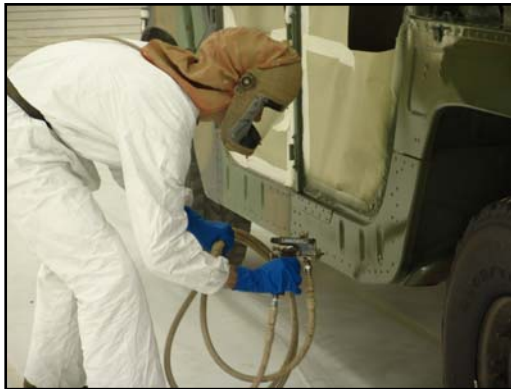
Beginning on December 5, 2006, STAR4D and Sherwin Williams staff, along with the assistance and cooperation of the CSMS Paint Shop located at Camp Dodge in Johnston, IA, coated two HMMWV'S M998A1 in good condition. The vehicles were coated at Camp Dodge by one of their CSMS Paint Shop painters. One vehicle was coated with MIL-D-53039 Silica F93G106 and the other with MIL-D-53039 Polymeric Bead (Beaded) F93G107. The current MIL-D-53039 Silica F93G106 is regarded as highly susceptible to marring.
